SNETTISHAM

CRATER LAKE - ALASKA

SECOND STAGE DEVELOPMENT

FINAL FOUNDATION REPORT

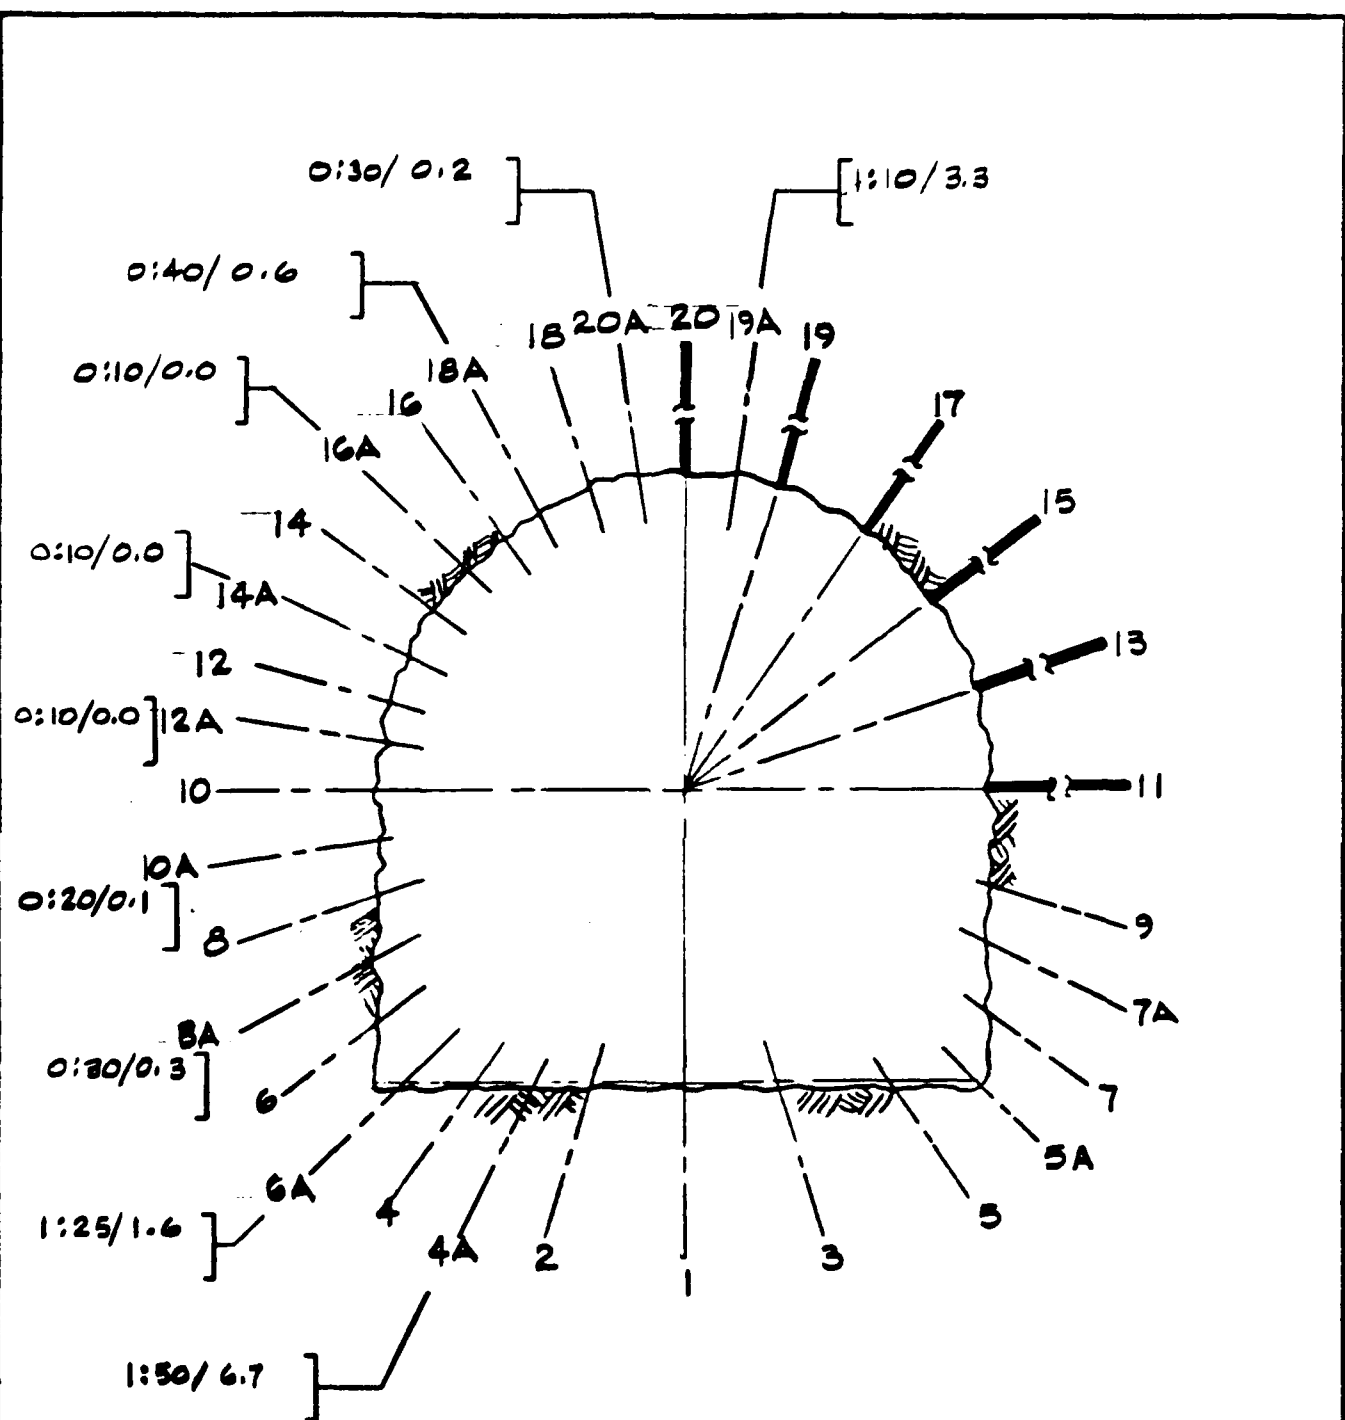
GROUT CURTAIN SUMMARY - STA. 67+30
 SUPPLEMENTARY GROUTING TO STA. 67+25

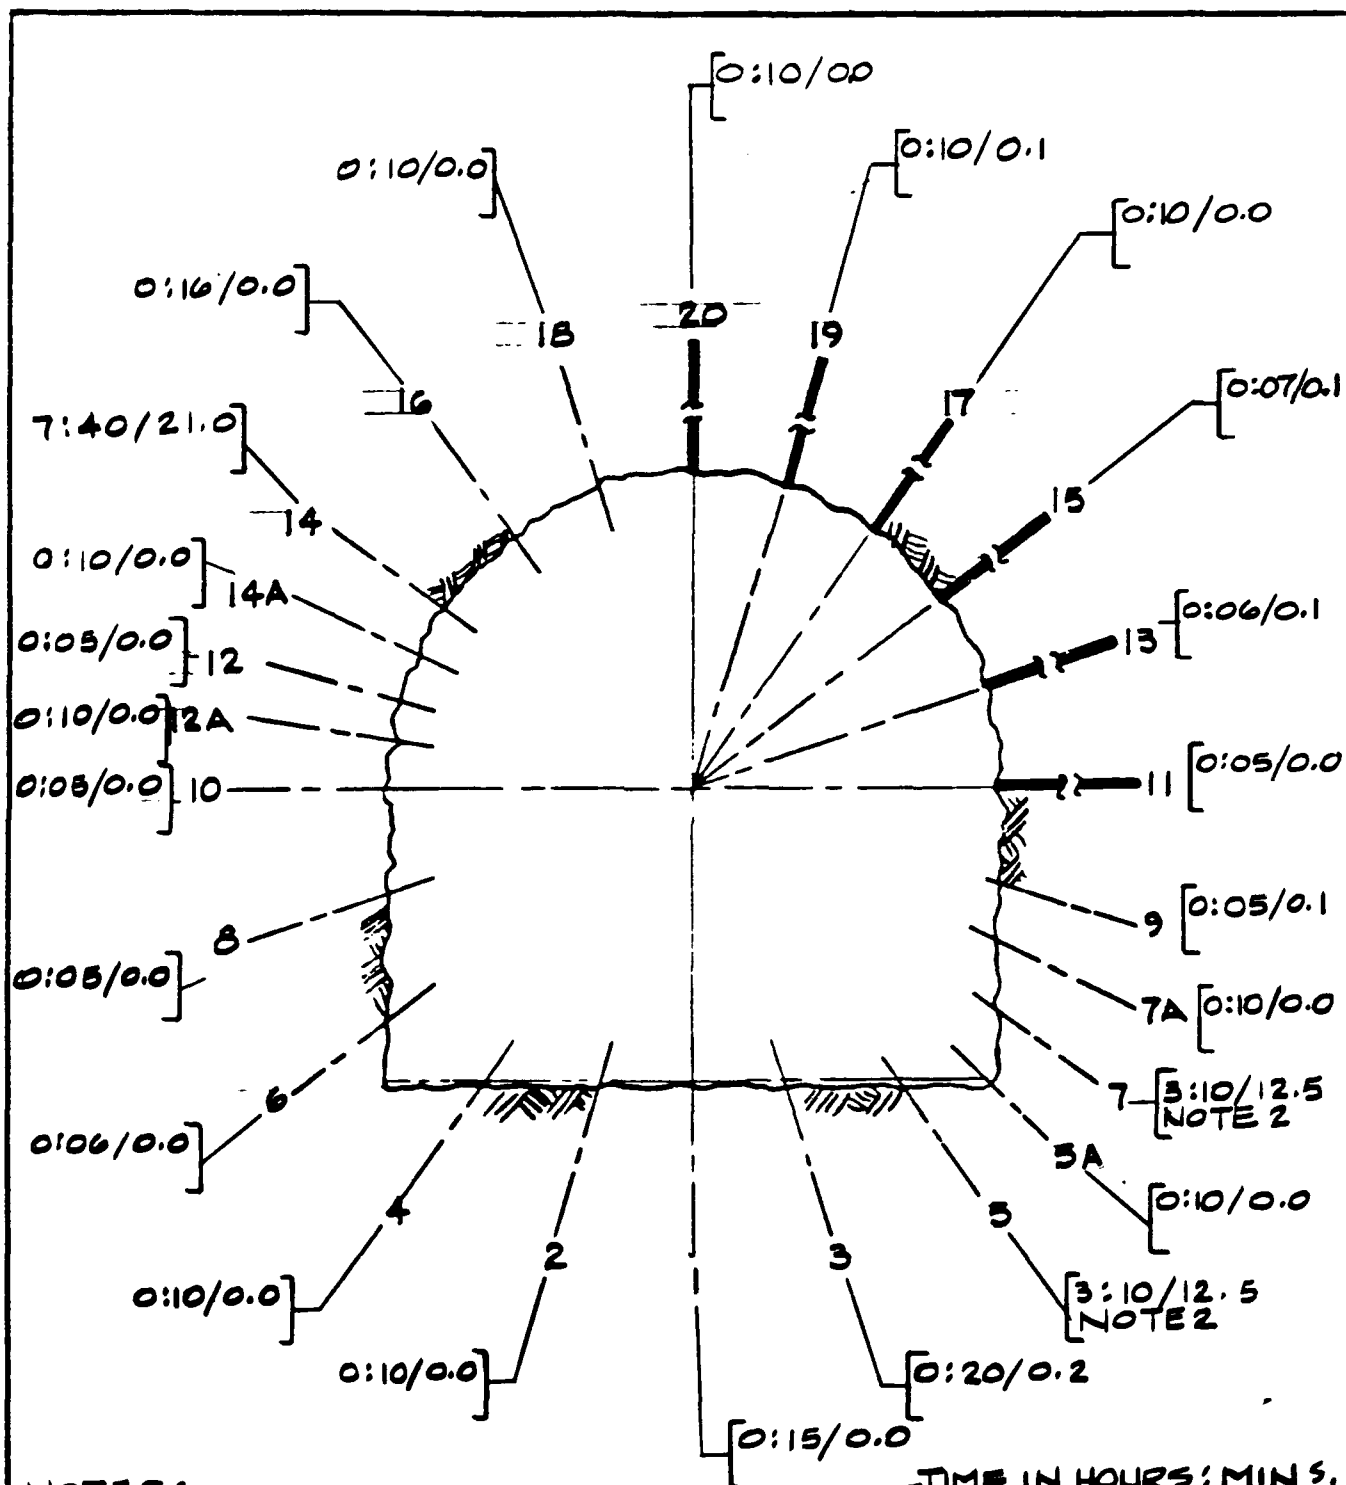
FIGURE G-7

1. EXPLANATION OF HOLE SUMMARY [0:20/0.0] TIME IN HOURS:MIN. S.
2. HOLES 5 & 7 WERE PUMPED SIMULTANEOUS QUANTITY IN CU. FT. (GROUT)
